doi: 10.3897/bgcardio.29.e114208

SUBACUTE RIGHT VENTRICULAR PERFORATION FROM A PASSIVE FIXATION PACEMAKER LEAD – A MULTIDISCIPLINARY DIAGNOSTIC AND MANAGEMENT WORK-UP

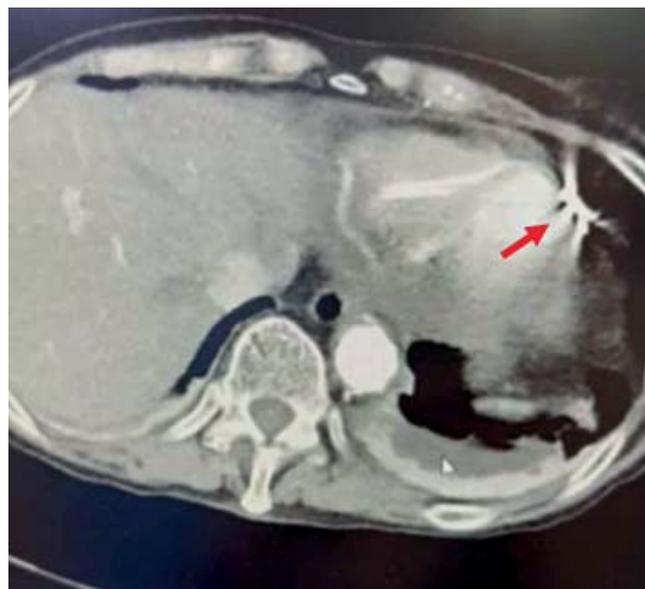
Fig. 1. Axial CT image of the heart showing pacemaker leads passing through the apex of the right ventricle (red arrow) and the tip of the pacemaker lead clearly seen outside (red arrow)

An 83-year-old female presented to the emergency department of our hospital with shortness of breath and presyncope started two days earlier, immediately after a single chamber permanent pacemaker implantation (VVIR) procedure with a passive lead fixation, because of a third-degree atrioventricular block. Since, she was directed from other hospital, they have already done a CT scan showing the ventricle lead tip traversing intramyocardially through the right ventricular apex and lying near the left ventricular apex in the pericardial cavity (Figure 1).

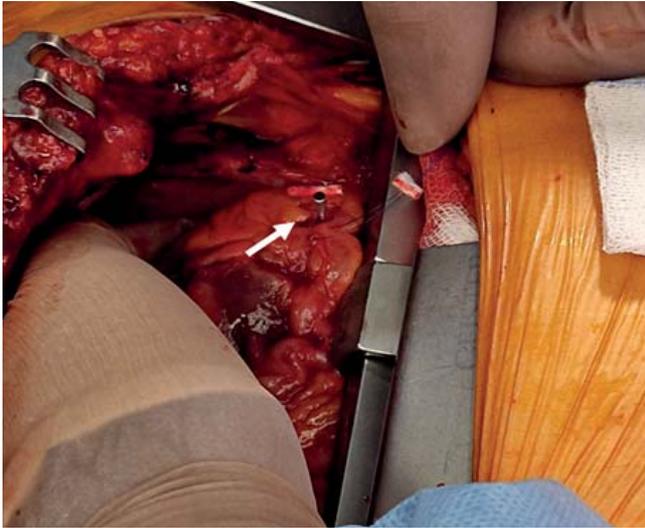
Fig. 2. Intraoperative image. Showing the pacemaker lead penetrated the right ventricular apex, reaching into the pericardium (white arrow)

Surgical management was judged clinically indicated and the patient underwent conventional median full-sternotomy and pericardiotomy showing a blood like effusion with massive adhesions. The pacemaker lead was visible in the pericardial space, perforated the apex of the right ventricle (Figure 2). The pacemaker lead with passive fixation was outside of the right ventricle with its tines up to the ring electrode and because of that it could not be removed transvenously, without firstly cutting the tip of the electrode. Otherwise the tines would further damage the myocardium of the right ventricle. After cutting the tip of the electrode, the lead body was removed transvenously, the apex of the right ventricle was repaired and a temporary pacemaker was implanted (Figure 3, Figure 4). In the postoperative period there was no pericardial effusion from transthoracic echocardiography and the patient remained in sinus rhythm for the first 24-hours. After that, she had a couple episodes of atrial fibrillation, followed by intermittent complete AV-block and AV-block 2:1. Because of the tachy-brady syndrome and the symptomatic bradycardia with high degree AV-block we decided on implantation of a permanent dual chamber pacemaker. On the sixth postoperative day a dual-chamber permanent pacemaker (PM Sphera DR MRI – SN FNC062750G, Medtronic Inc., Minneapolis, MN, USA) implantation was performed. A 7-French active fixation lead (Capsure Fix Novus 4076 52 cm – SN BBL1663141) was inserted via the left axillary vein approach and positioned in the right atrial (RA) appendage and the right ventricular lead (Capsure Fix Novus 4076 58 cm – SN

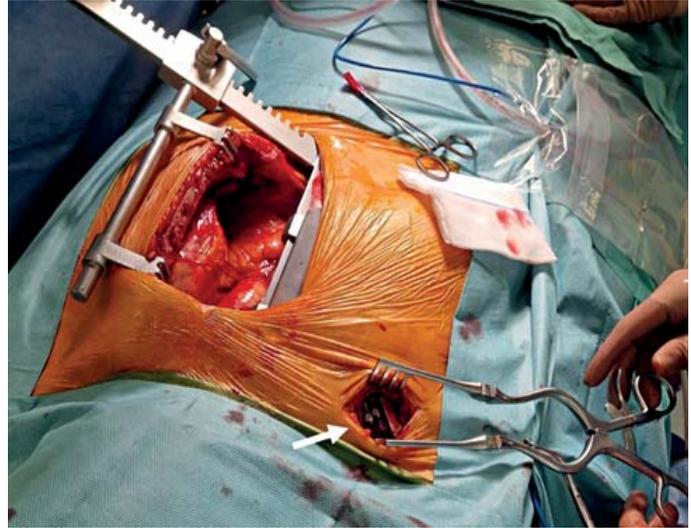
Fig. 3. Intraoperative image after cutting the tip of the electrode and opening the pacemaker pocket in order to transvenously remove the body and the lead (white arrow)

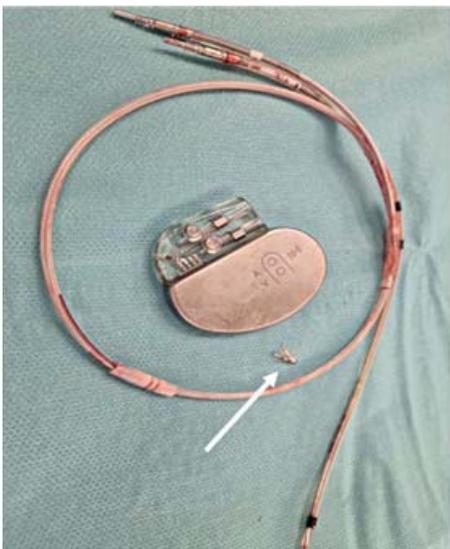
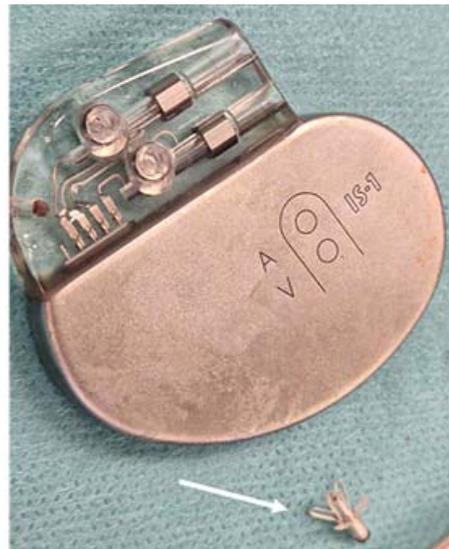
Fig. 4. The extracted permanent pacemaker. The tip with the tines (white arrow) is showed

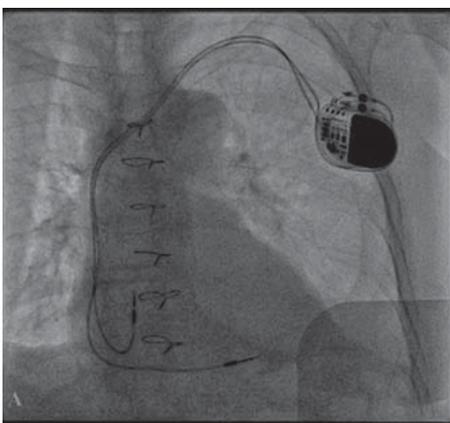
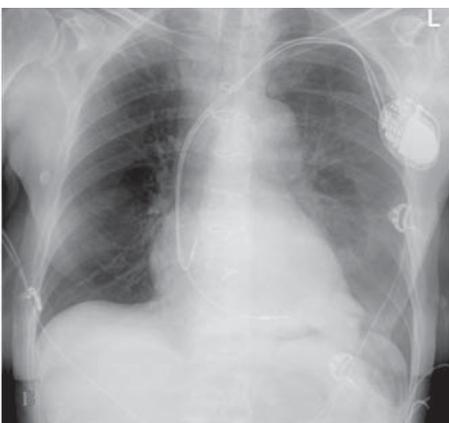
A B

Fig. 5. Image 'A' at the end of the procedure showing the implantation side of the pacemaker body and leads. Image 'B' is the chest X-ray one-day post implantation showing the pacemaker lead in place

BBL1672556) was implanted in the apical septum without any complication. One-day post-implantation, the chest X-ray showed the pacemaker lead in place

with the appropriate slack. The pacemaker parameters were satisfactory and the patient was discharged home on the same day (Figure 5).
